Watermill Center

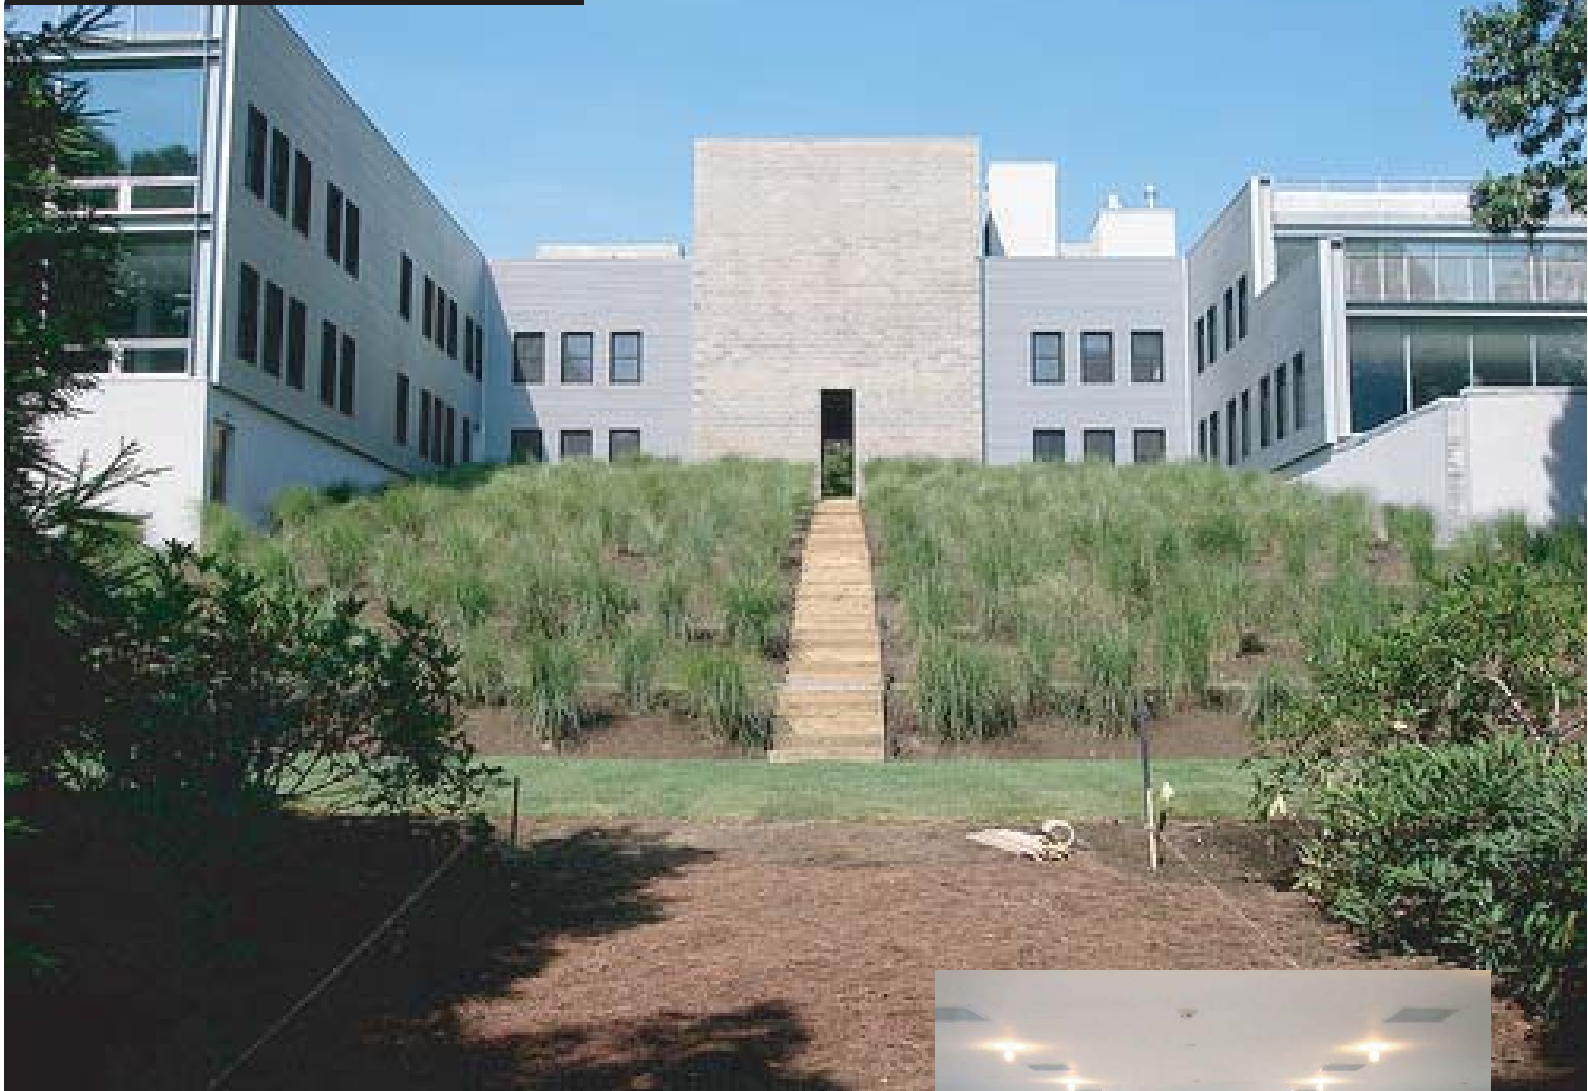
Michielli and Wyetzner Architects took over the design and construction of Robert Wilson's Watermill Center in Eastern Long Island in 2004. The building required a complete gutting of the exterior facade, including all cladding, wallboard, windows, and the replacement of window wall systems, which were damaged due to lack of tolerance between the steel structural frame and the glazing system.

A zinc sinewave cladding, set against deep recessed black painted windows, was chosen for the facades, with an eifs base. An aluminum glazing system was designed to infill the steel frame.
